CONCRETE CLOTH™ DITCH LINING CASE STUDIES

12.02.10 Case Study : Edale, Derbyshire

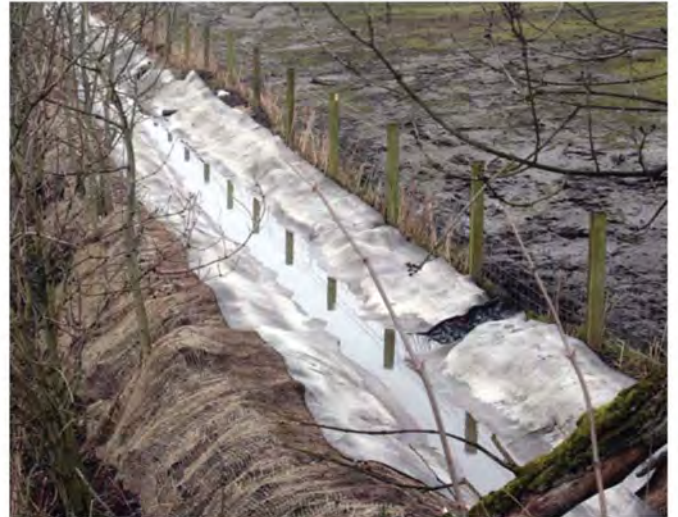
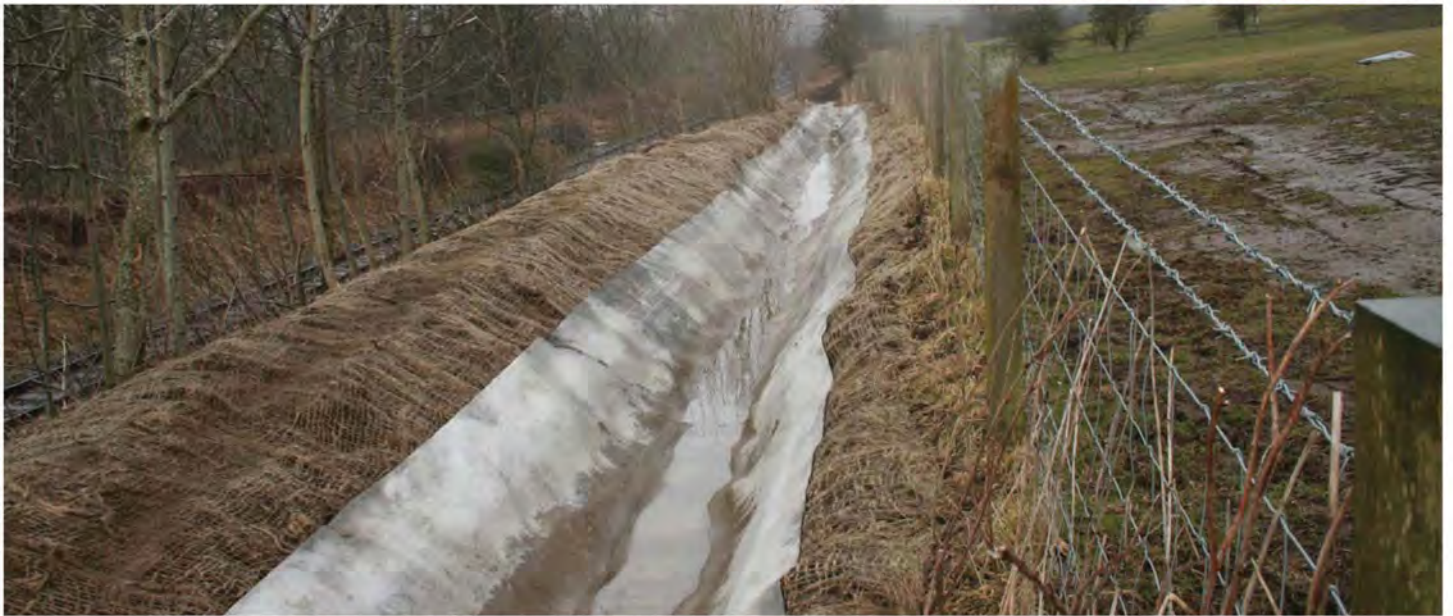
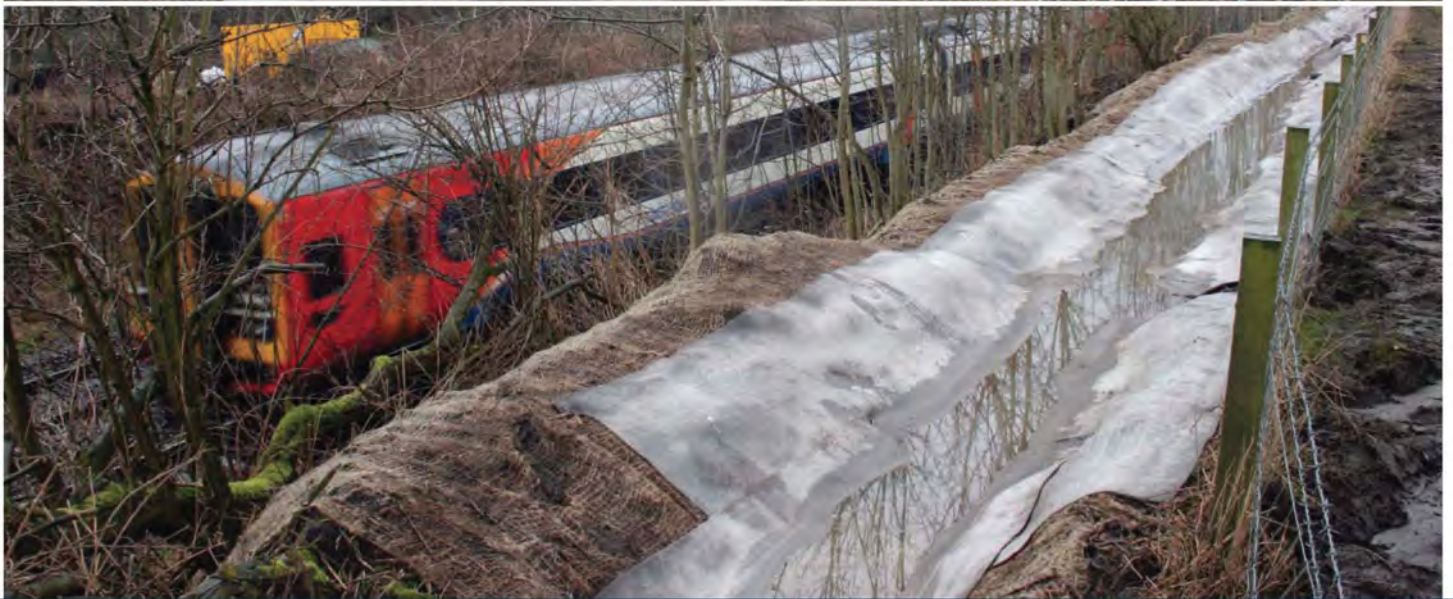
Based on the success of previous ditching trials, Network Rail decided to utilise Concrete Cloth to upgrade and line an existing trench. The Cloth was supplied in man-portable lengths to overcome issues of plant access. In total, a 110m length of ditch, incorporating land drains and sections of varying width and profile was installed.
