CONCRETE CLOTH™ DITCH LINING CASE STUDIES

12.08.10 Case Study : RSSC Canal Lining Trial, Swaziland

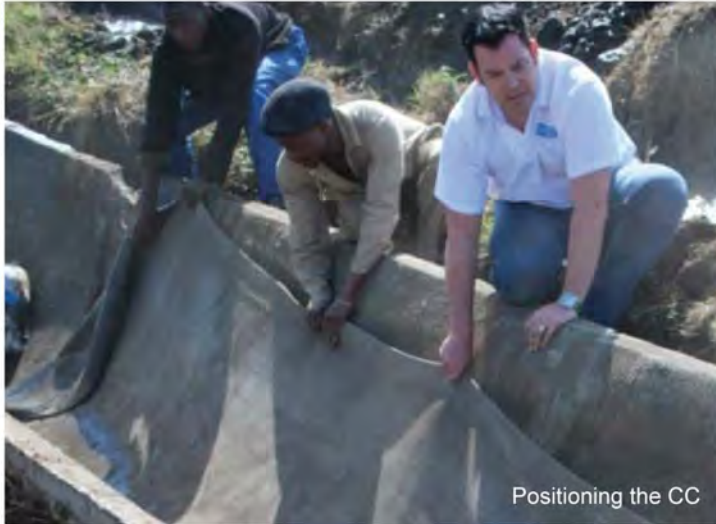
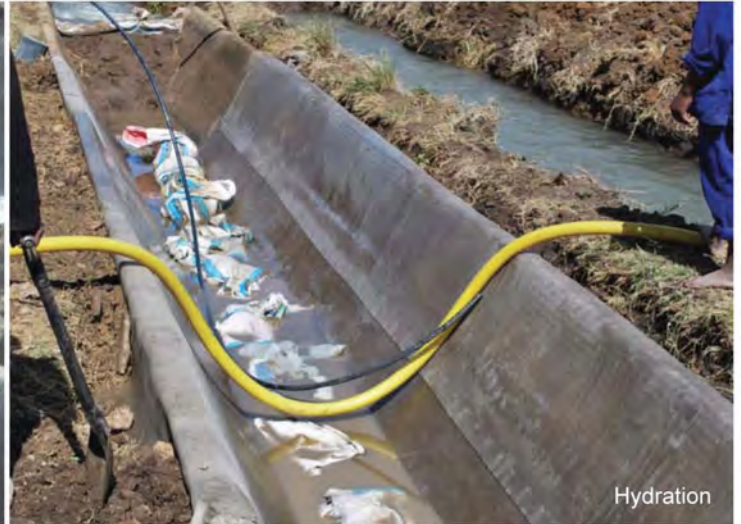
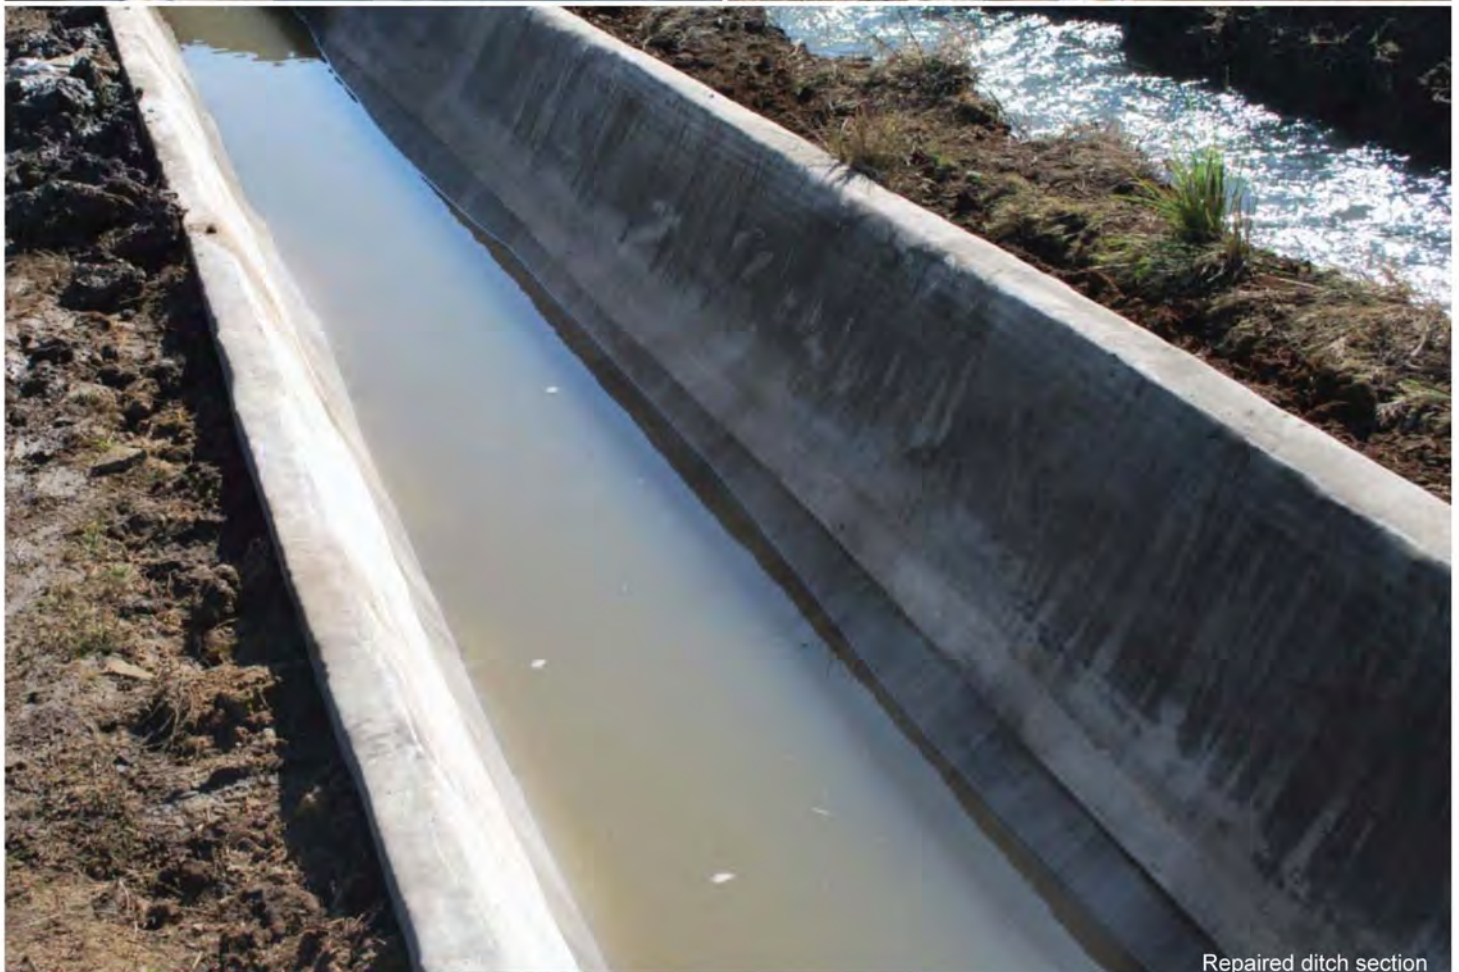
In August 2010, Concrete Canvas SA conducted a canal lining trial in Mhlume, Swaziland, using Concrete Cloth (CC). Four layers of CC4 were laid in position and stapled together at the base before compressing the joints with sandbags. A strip of PVC, 100mm wide was removed from the backing, to create a concrete bond between adjacent layers.

The work to repair the 40m section of the canal took three hours to complete, vastly quicker and more effective than conventional lining techniques.
