CONCRETE CLOTH™ DITCH LINING CASE STUDIES

29.09.10 Case Study : Golborne, Warrington

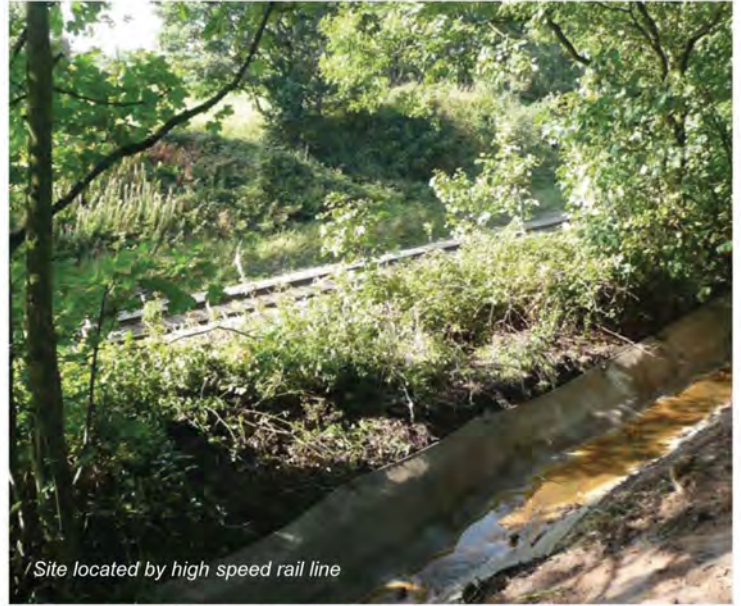
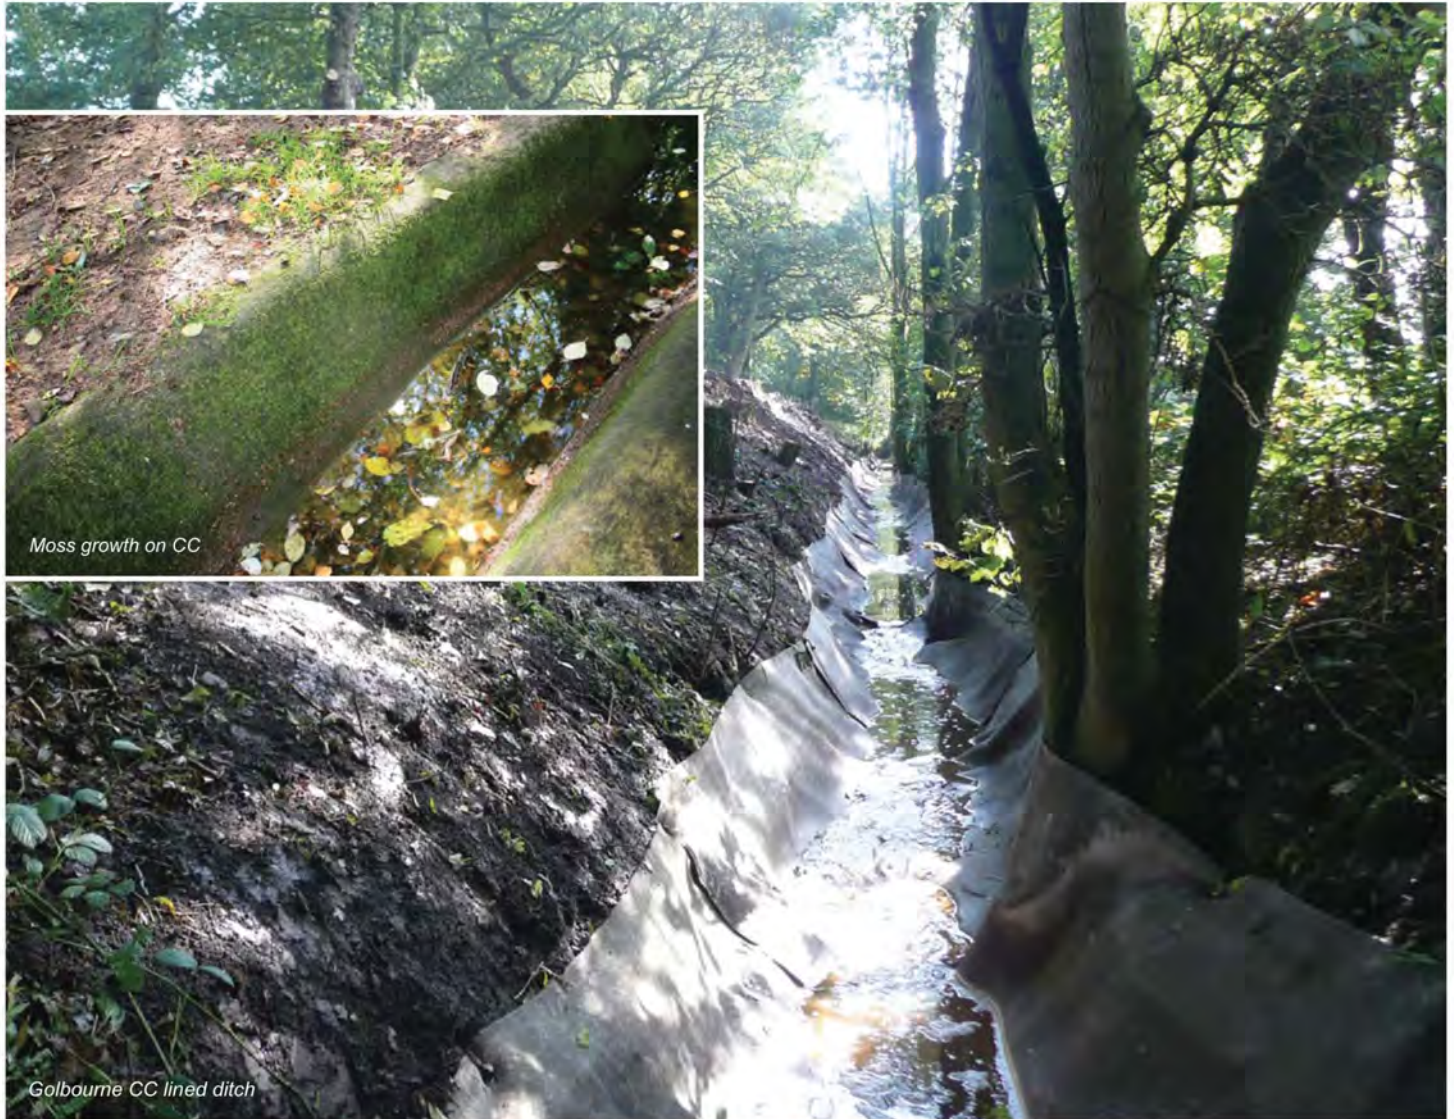
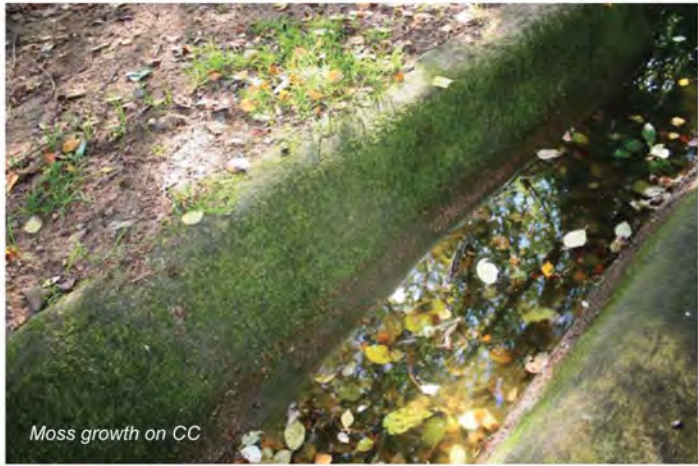
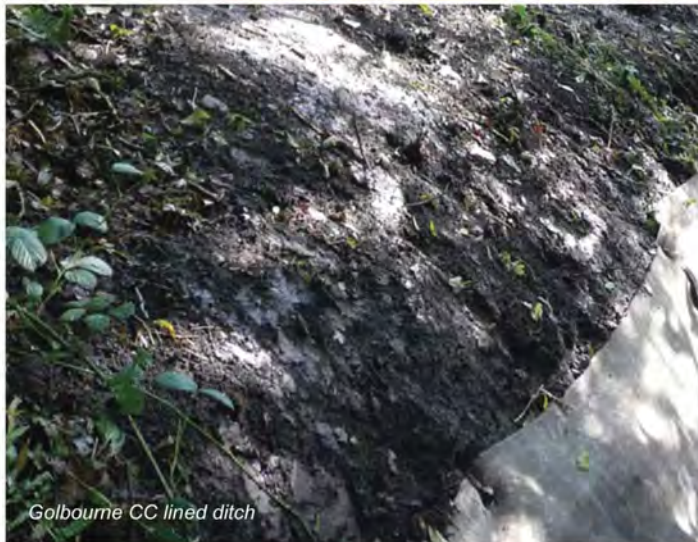
Network Rail contracted Murphy Group to clear and line an open drainage ditch that had been clogged by growth and was at risk of destabilising the railway embankment. Concrete Cloth (CC) was specified to line the cleared ditch to prevent further growth and to stabilise the bank. The access to the site was poor, across farmland and located within a copse on a steep bank that ran along a high speed rail line. The use of CC allowed Murphy group to line the 120m long ditch in just 1.5 days.

A key benefit of using CC, is it's ability to conform to the natural contours of a ditch, providing an aesthetic in keeping with the surrounding environment. CC will naturally 'green' over time as the textured top surface allows moss growth, whilst the fibre-reinforced concrete layer will prevent root-growing vegetation, which would otherwise restrict water flow and increase maintenance costs.
