## 03.08.10 Case Study : Fairlight Cove, East Sussex

In June 2008 Rother Council commissioned a major coastal protection project at Fairlight Cove on the south coast of England. The area has suffered from extreme landslide regression resulting in the loss of residential property and further threatening a large number of dwellings.

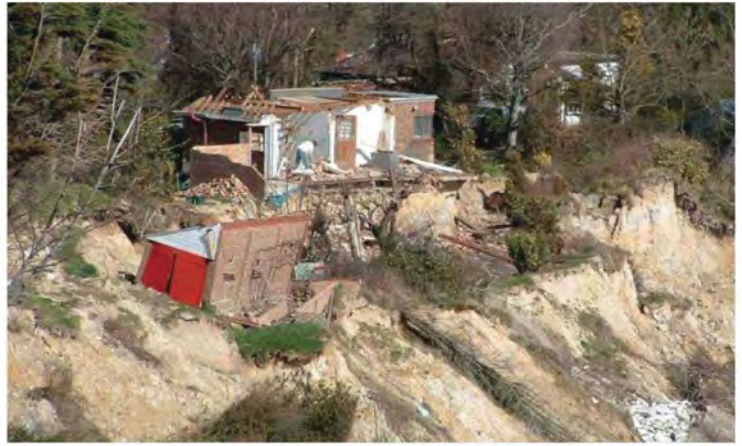
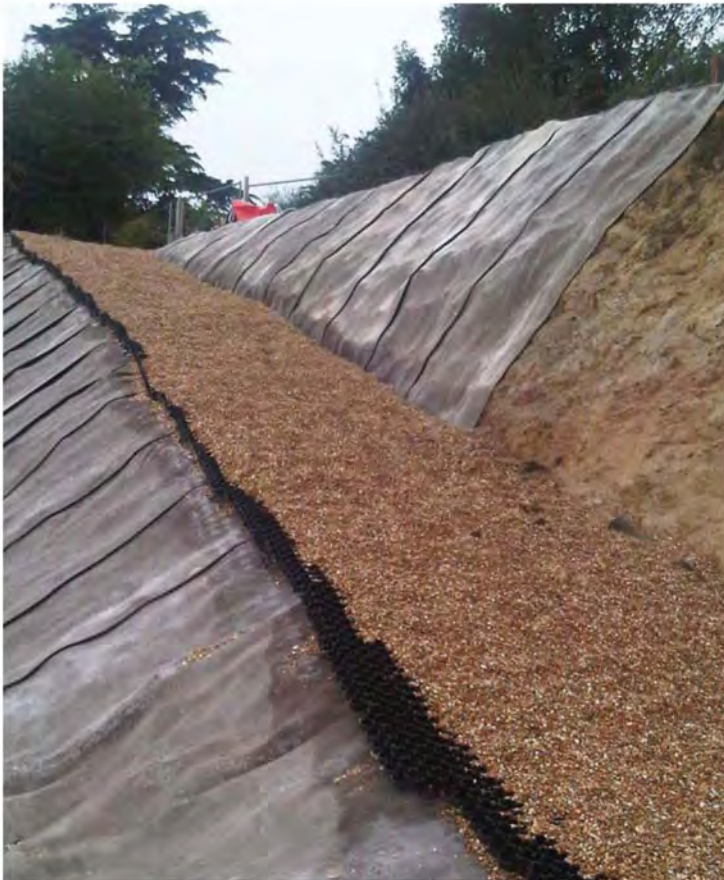
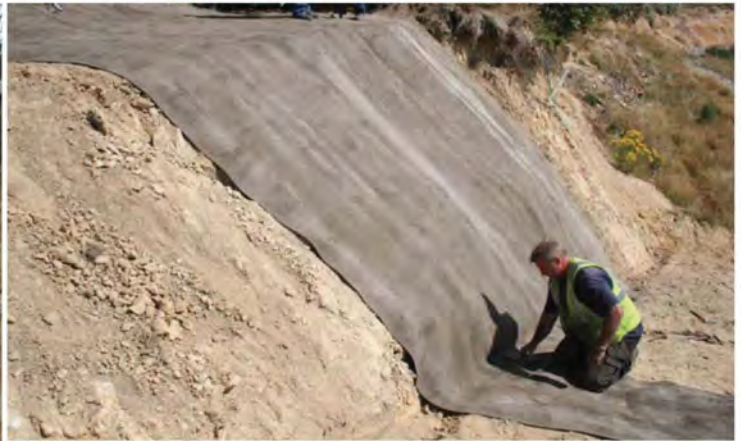
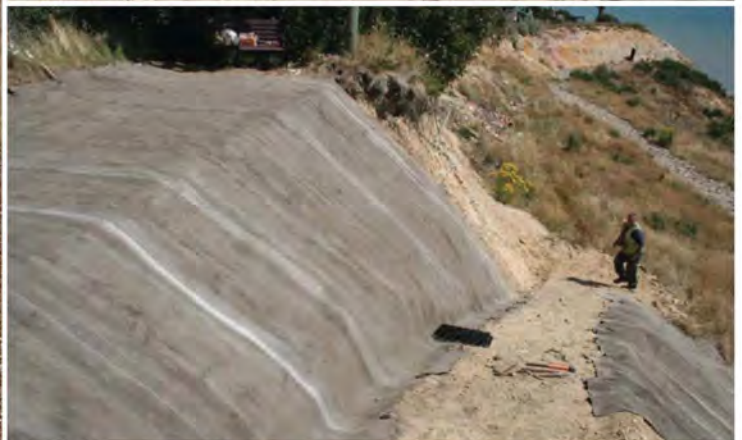
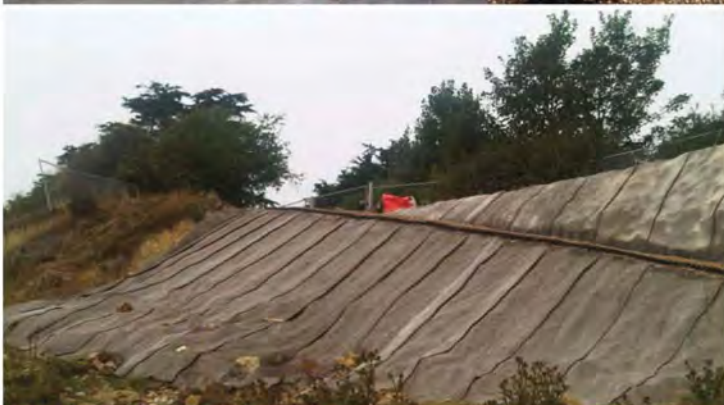
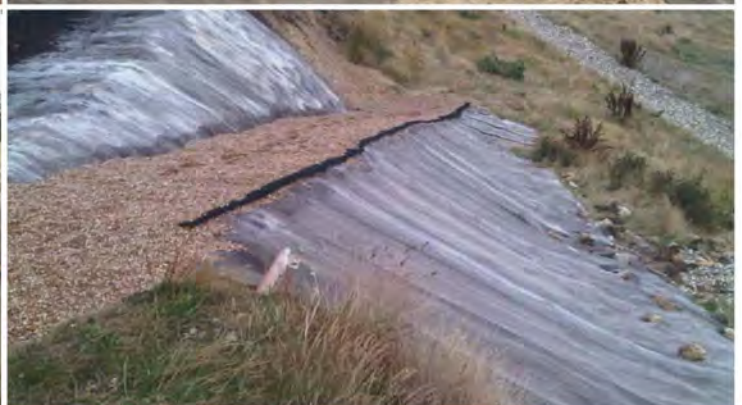
CC4 (4mm Concrete Cloth) was specified by Rother Council's geotechnical consultants to stabilise and protect a sub-vertical failure surface close to a key drainage facility. The steep nature of the slope prevented conventional slope stabilisation techniques such as vegetation growth. The Cloth was supplied as man-portable rolls allowing work to be completed in areas with restricted access and where conventional concreting would be impossible.
